GERMAN SELF-PROPELLED GUNS

**Self-propelled artillery
anti-tank and anti-aircraft guns**

Gordon Rottman

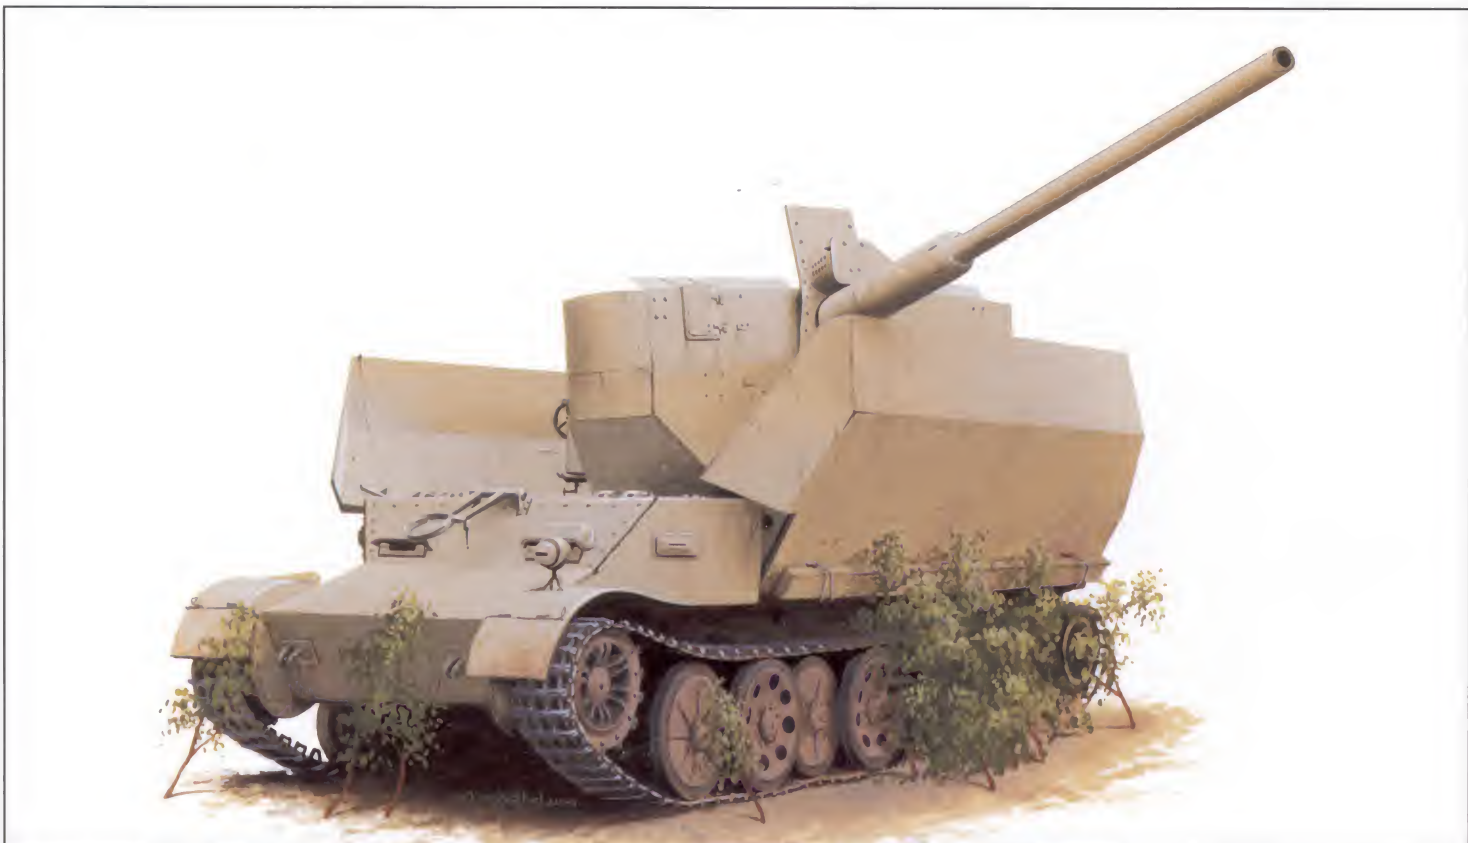
8.8cm FlaK auf Sonderfahrgestell (Pz.Sfl.IVc), Germany, spring 1944

This was an experimental effort first proposed in June 1942 of mounting an 8.8cm Flak 41 anti-aircraft gun on a fully tracked chassis to provide Panzer divisions with self-propelled heavy flak. The sides and rear could be lowered to provide a large platform for the crew. This vehicle is painted solid dark yellow (RAL 7028). The 8.8cm Flak 41 was replaced by an 8.8cm Flak 37 in March 1944 and the vehicle sent to Italy for trials with 26.Panzer-Division.

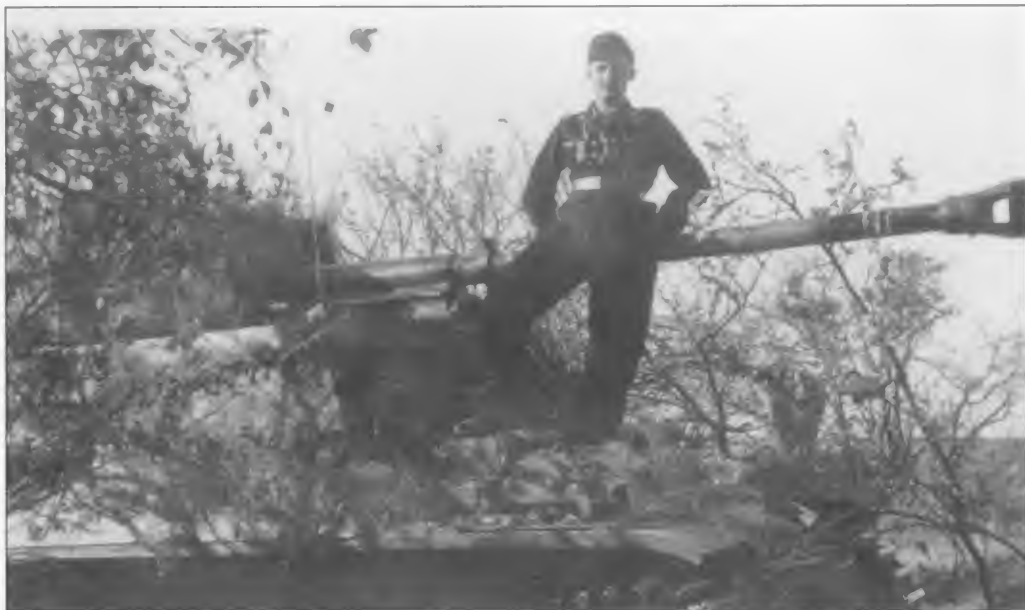
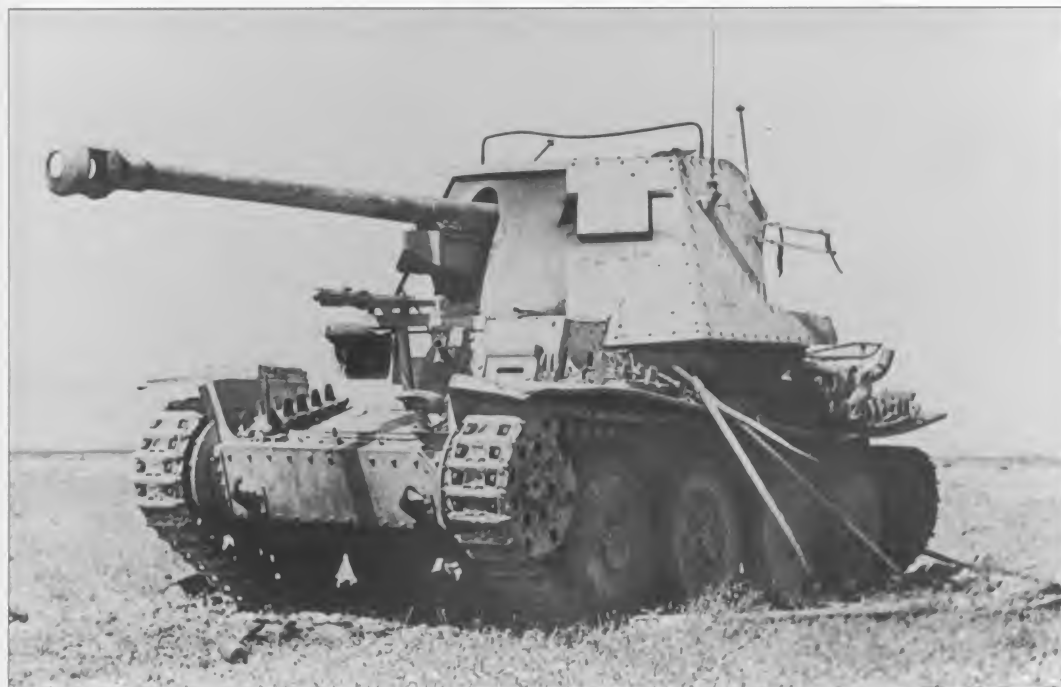
The 7.5cm PaK 40/3 auf Pz.Kpfw.38(t) Ausf.H variant of the Marder III (Sd.Kfz.138), was built on a Czechoslovak vz.38 light tank chassis, the Pz.Kpfw.38(t). There were considerable differences between the Ausf.H and M. Both had an open-top compartment, but the Ausf.H was open in the rear. The Ausf.H carried 38 rounds of 7.5cm ammunition and the gun had a 30-degree left and right traverse. Its armor was 8-50mm thick. Between late 1942 and mid-1943, 418 Ausf.H's were built and employed on all fronts with the first being assigned to Panzerjäger-Abteilungen in May 1943. This particular Marder III, inscribed with "Paula" in white over a faint Balkenkreuz, had a large piece of the gun compartment's left side plating was blown off by a direct hit.

The right profile of a 7.5cm PaK 40/3 auf Pz.Kpfw.38(t) Marder III Ausf.H. The horizontal apparatus below the gun barrel is the barrel lock lowered for firing. Beneath it can be seen the barrel of the 7.92mm MG-37(t) (Czechoslovak vz.37) machine gun mounted in the center of the bow compartment. It did not carry an MG-34 machine gun internally in the gun compartment as did the Ausf.M.

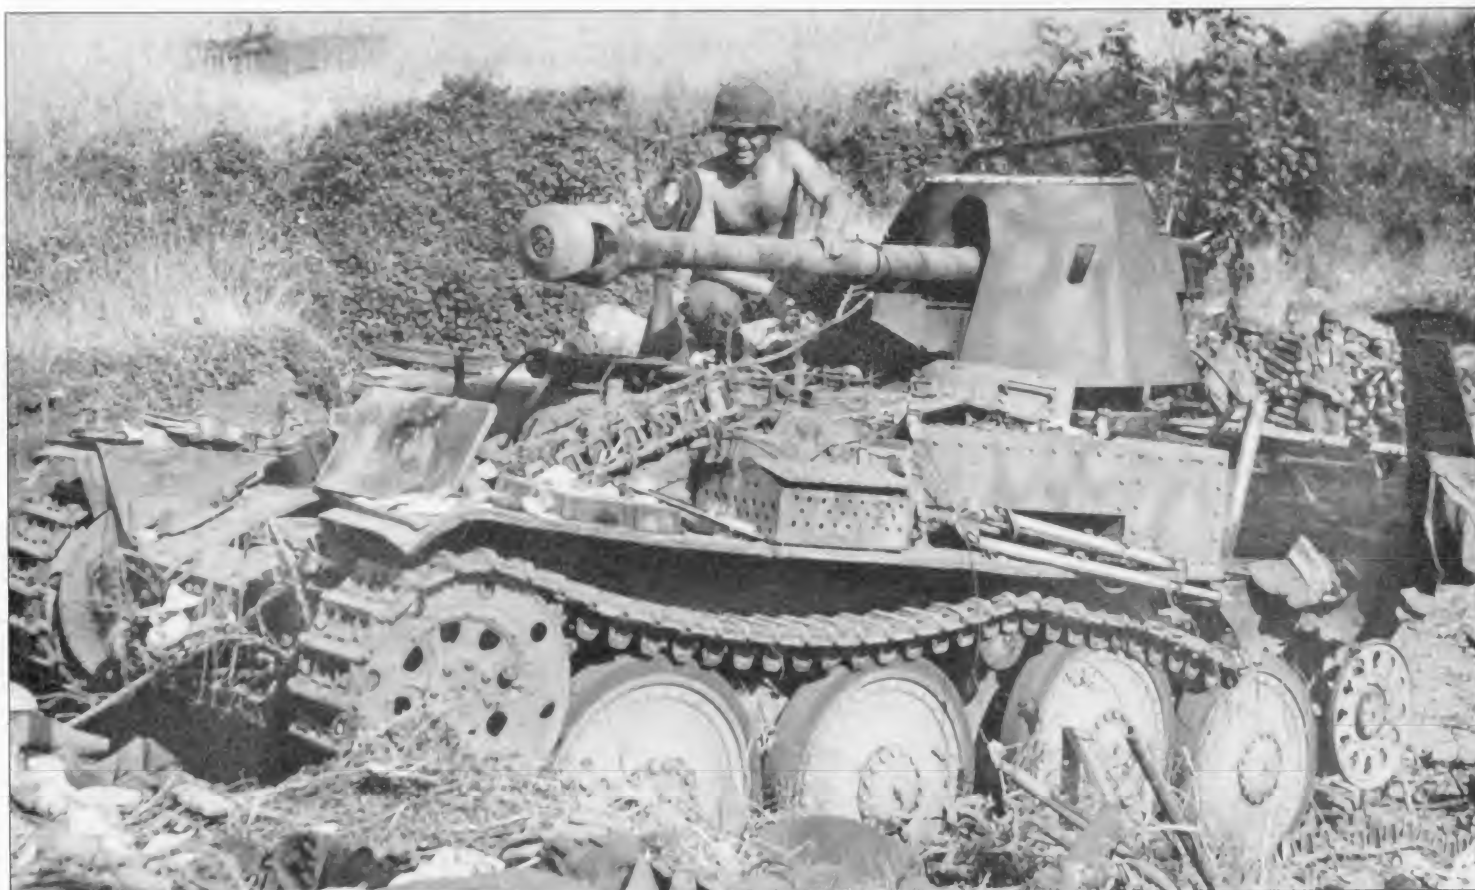
An American soldier examines this Marder III Ausf.M in Italy, which took a direct hit in its firing position. Its ammunition detonated blowing the rear overhanging gun compartment apart. This photograph provides a good view of the 7.5cm gun's shield unhindered by the superstructure.

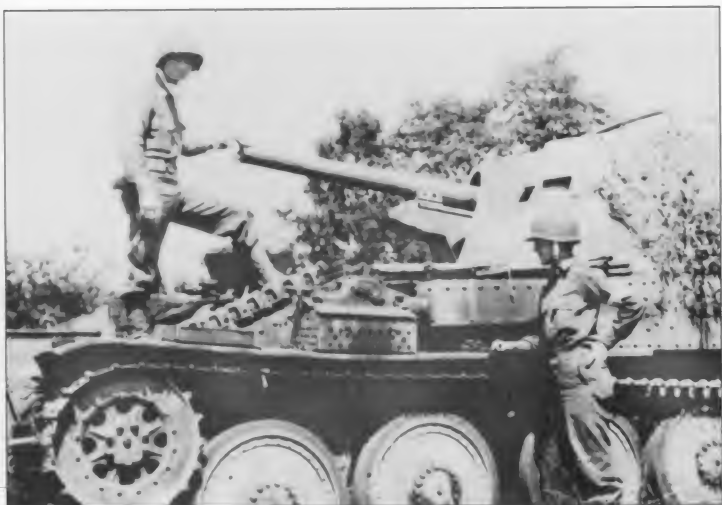
The 7.5cm PaK 40/3 auf Pz.Kpfw.38(t) Marder III Ausf.M (Sd.Kfz.138) was built on a much-modified Czechoslovak vz.38 light tank chassis. The engine relocation allowed the gun compartment to be positioned in the rear to provide a more efficient crew accommodation though the gun could only traverse 21 degrees left and right. The hull front and driver's compartment was much different too than the Ausf.H's. The armor was lighter though, 8-20mm, but the frontal glacis was very well sloped. It carried less ammunition than the Ausf.H, only 27 rounds. A total of 975 Ausf.Ms were produced. This one's gun barrel had been burst, probably by the capturing Americans to prevent its reuse.

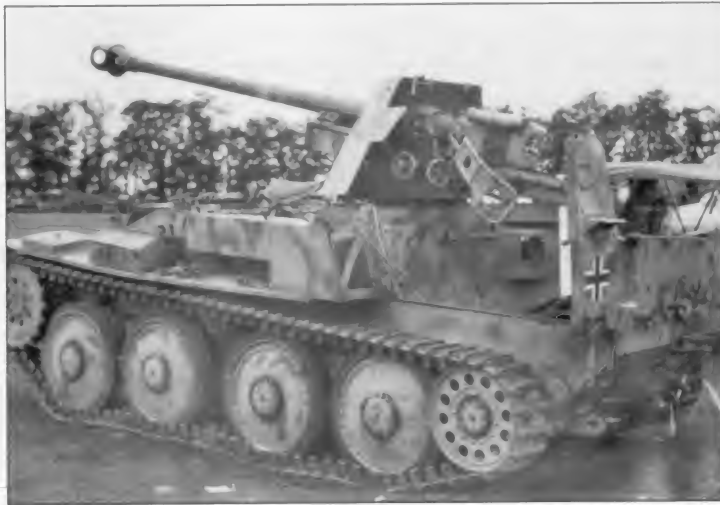
This Marder III Ausf.M has had its side and rear panels blown off revealing the 7.5cm PaK 40/3. The gun's breech guard is bent downward. Note the small Balkenkreuz on the rear hull. The camouflage pattern consists of crude spray-painted bands on the dark yellow base. This vehicle was captured in Germany in 1945.

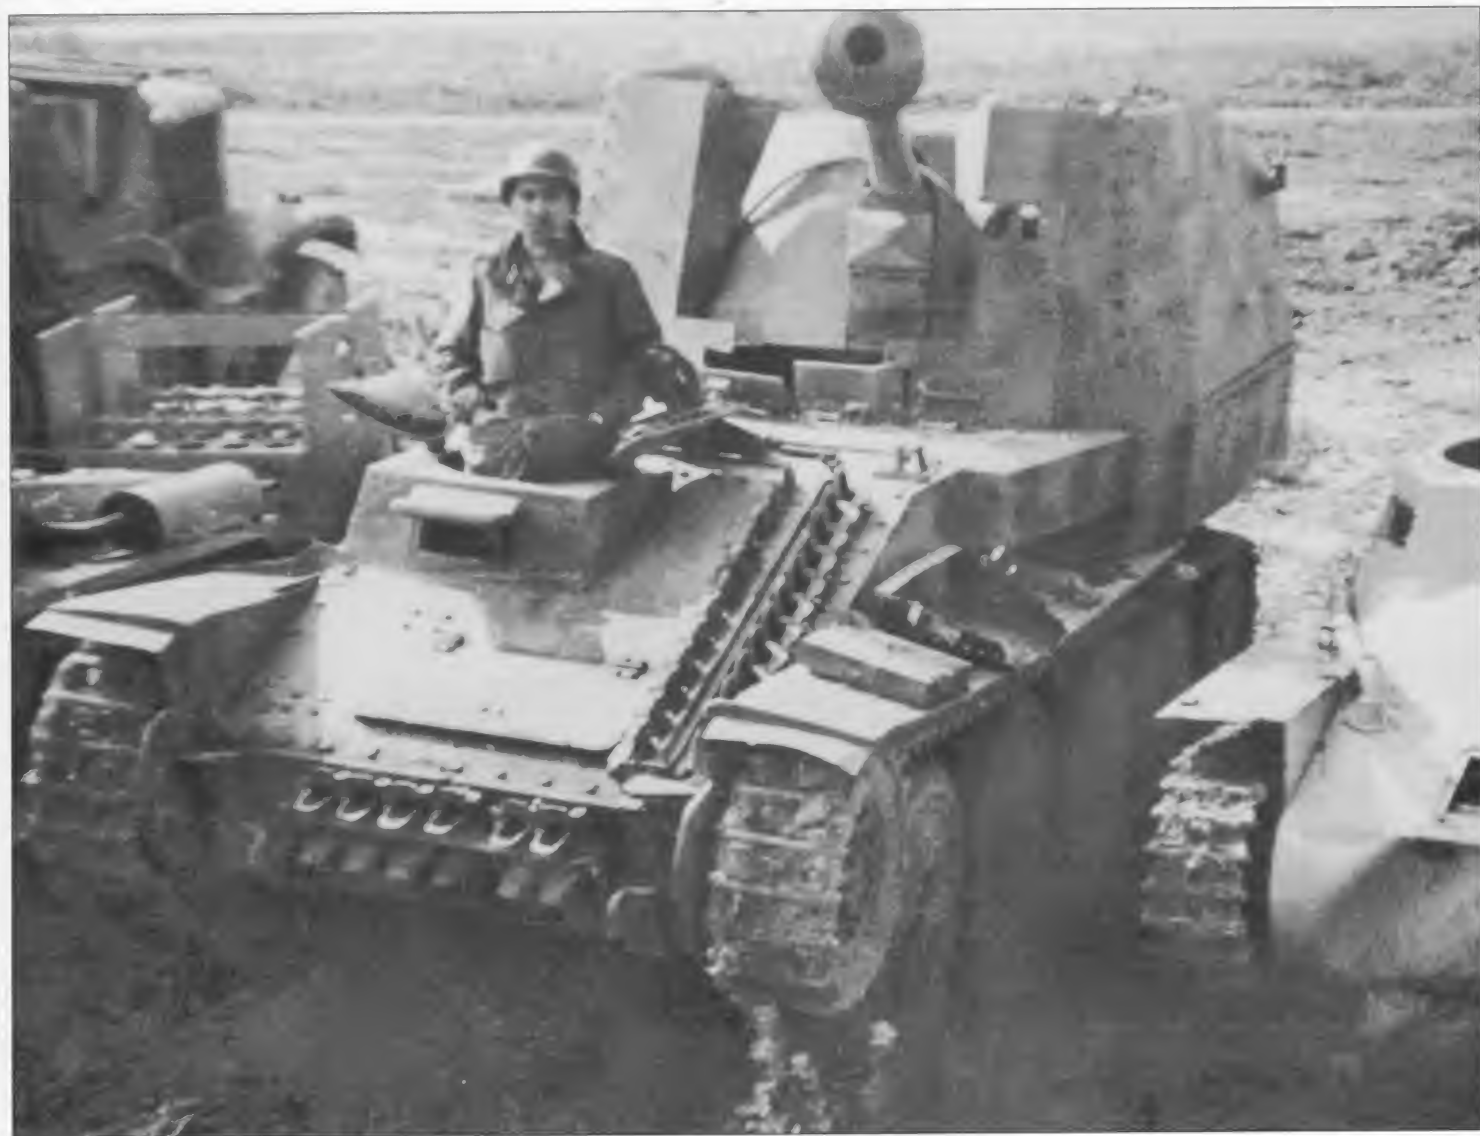
A 7.5cm PaK 40/3 auf Pz.Kpfw.38(t) Marder III Ausf.M with the late production hull identified by the welded flat plates around the driver's compartment. Early production vehicles has a rounded cast driver's compartment. The positioning of the track sections on the upper and lower glacis was standard.

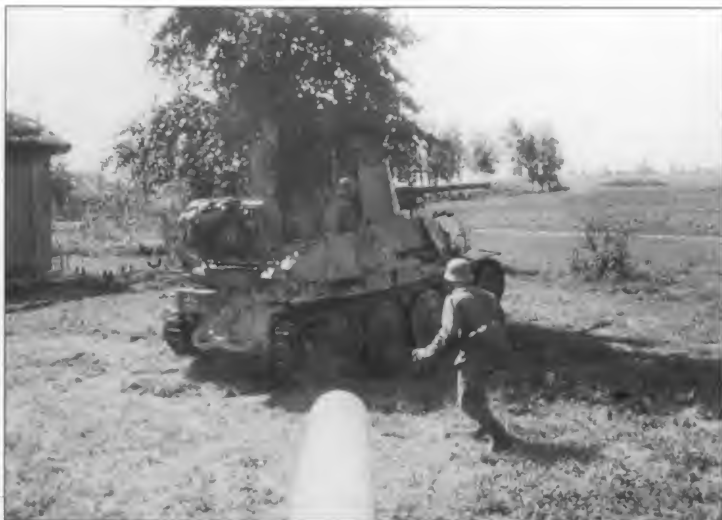
Another type of Marder III, of much different design than the Sd.Kfz. 138, was the Sd.Kfz. 139, the Panzerjäger 38(t) für 7.62cm PaK 36(r). Both were built on Pz.Kpfw.38(t) chassis, but the superstructures were much different. The Sd.Kfz. 139, in similar concept to the Sd.Kfz. 132 Marder II had its gun mounted atop the superstructure. This Marder III (Sd.Kfz. 139) is in action in Russia, August 1942. A storage rack was fitted in the rear. Note the small Balkenkreuzen on the superstructure sides and rear storage box. They equipped both separate and Panzer division Panzerjäger-Abteilungen.

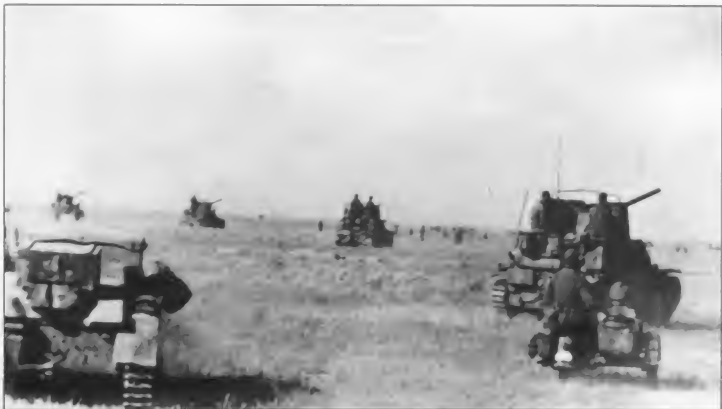
The superstructure of this Marder III (Sd.Kfz. 139) features the battalion insignia. Note the six 20-liter fuel cans fastened on the forward hull. Used for long movements, these would be discarded when going into combat and probably dropped off at a battalion dump.

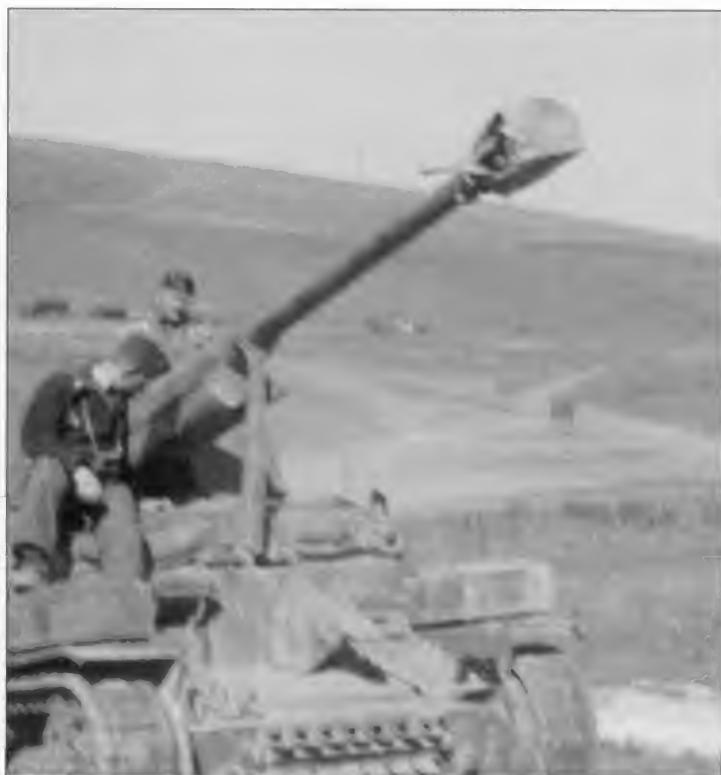
The Marder III (Sd.Kfz. 139) mounts a 7.62cm PaK 36(r) gun. So many Russian 76.2mm guns were captured that it became one of the most numerous antitank guns in German service in both towed and self-propelled mountings. It could punch through 120mm of armor with the German-produced tungsten-cored armor-piercing rounds at 500 meters.

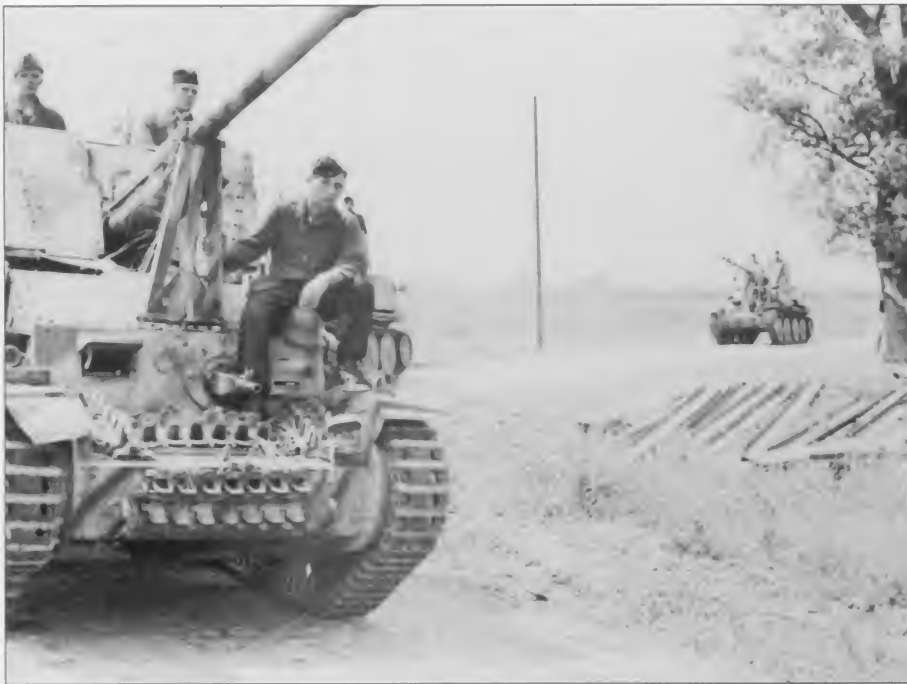
This Marder III (Sd.Kfz.139) provides a good view of the fittings, vision ports, 7.92mm machine gun with its armored housing, and other features of the bow.

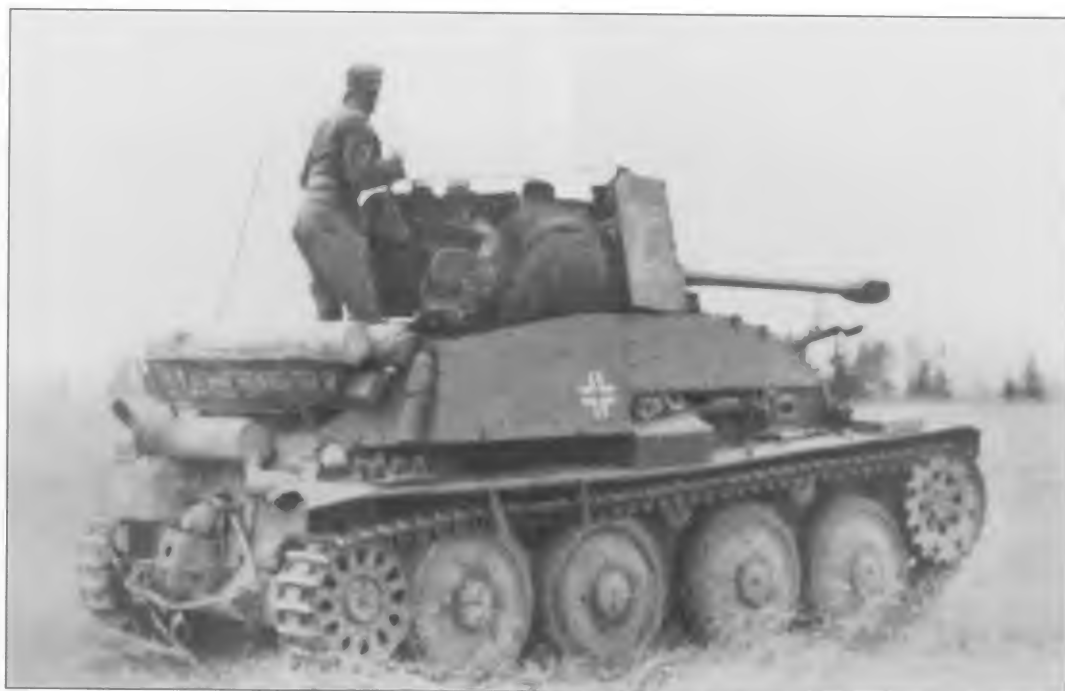
A Marder III (Sd.Kfz.139) prepares to fire its 7.62cm gun. The crew has stacked logs in the wire mesh equipment rack in an effort to provide some fragmentation protection to the rear. The vehicle is painted a solid color, possibly dark gray. The vehicle number is probably red outlined in white. Many units used two-digit numbers, but it appears that three-digit numbers were more common. Two-digit numbers identified the gun and company while three-digit numbers, as used by tank units, identified the gun, platoon, and company.

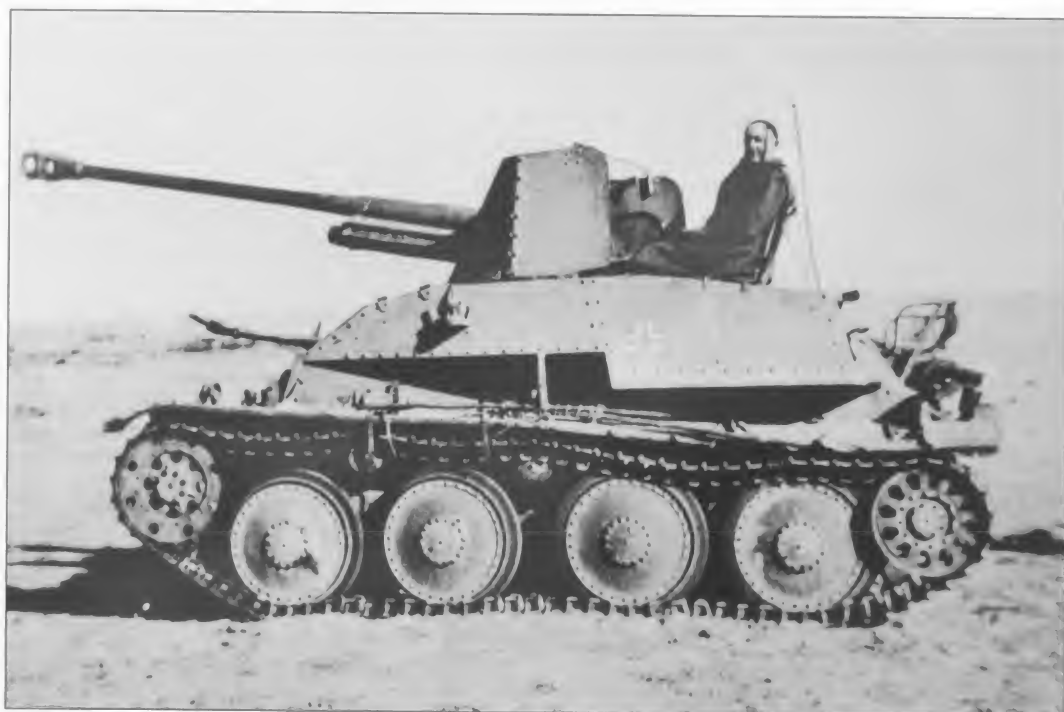
The Marder III's four-man crew was somewhat exposed. The gun traverse was 21 degrees right and left. Like the Marder III Ausf.H, a 7.92mm machine gun was mounted in the center of the bow compartment. Thirty rounds of main gun ammunition were carried. From early 1942, 363 were produced on Pz.Kpfw.38(t) Ausf.G and H chassis. A British soldier sits atop this Marder III in North Africa, 1943.

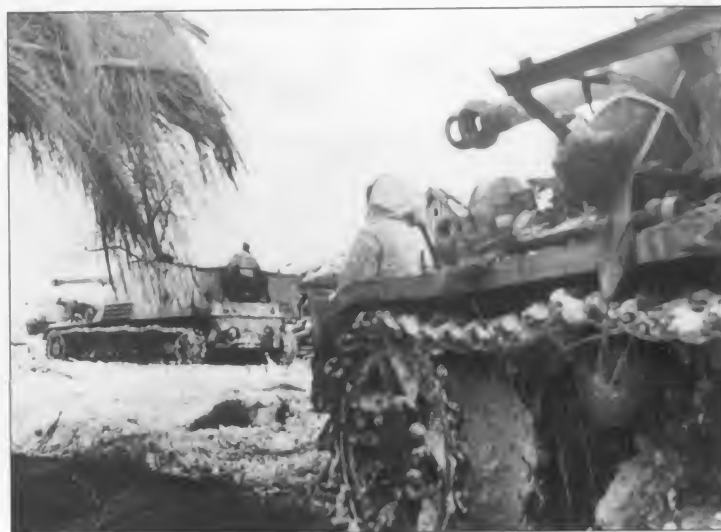
The rear view of a whitewashed 'Nashorn' passing through a Russian village. This view displays the double rear opening doors of the gun compartment.

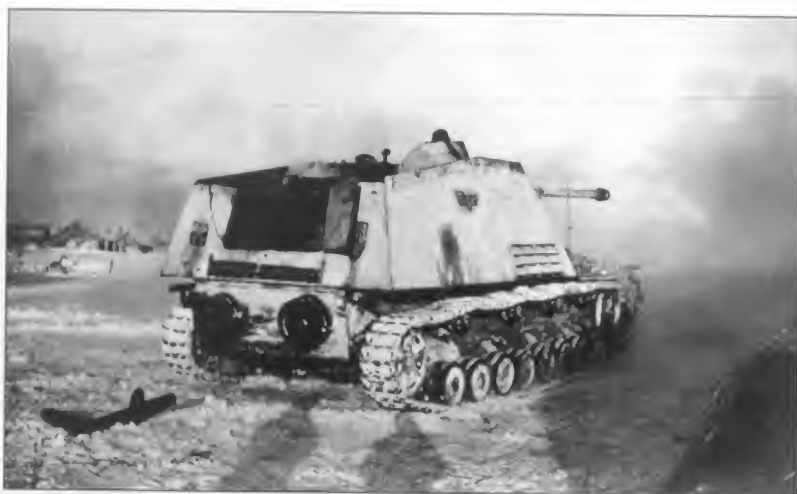
The business end of a 'Nashorn' with its 8.8cm gun in travel lock position. The vehicle has been whitewashed. Its one headlight over the left track guard has a blackout cover. The 'Nashorn' carried a Fu.Spr.Ger.d radio. An MG-34 was carried internally.

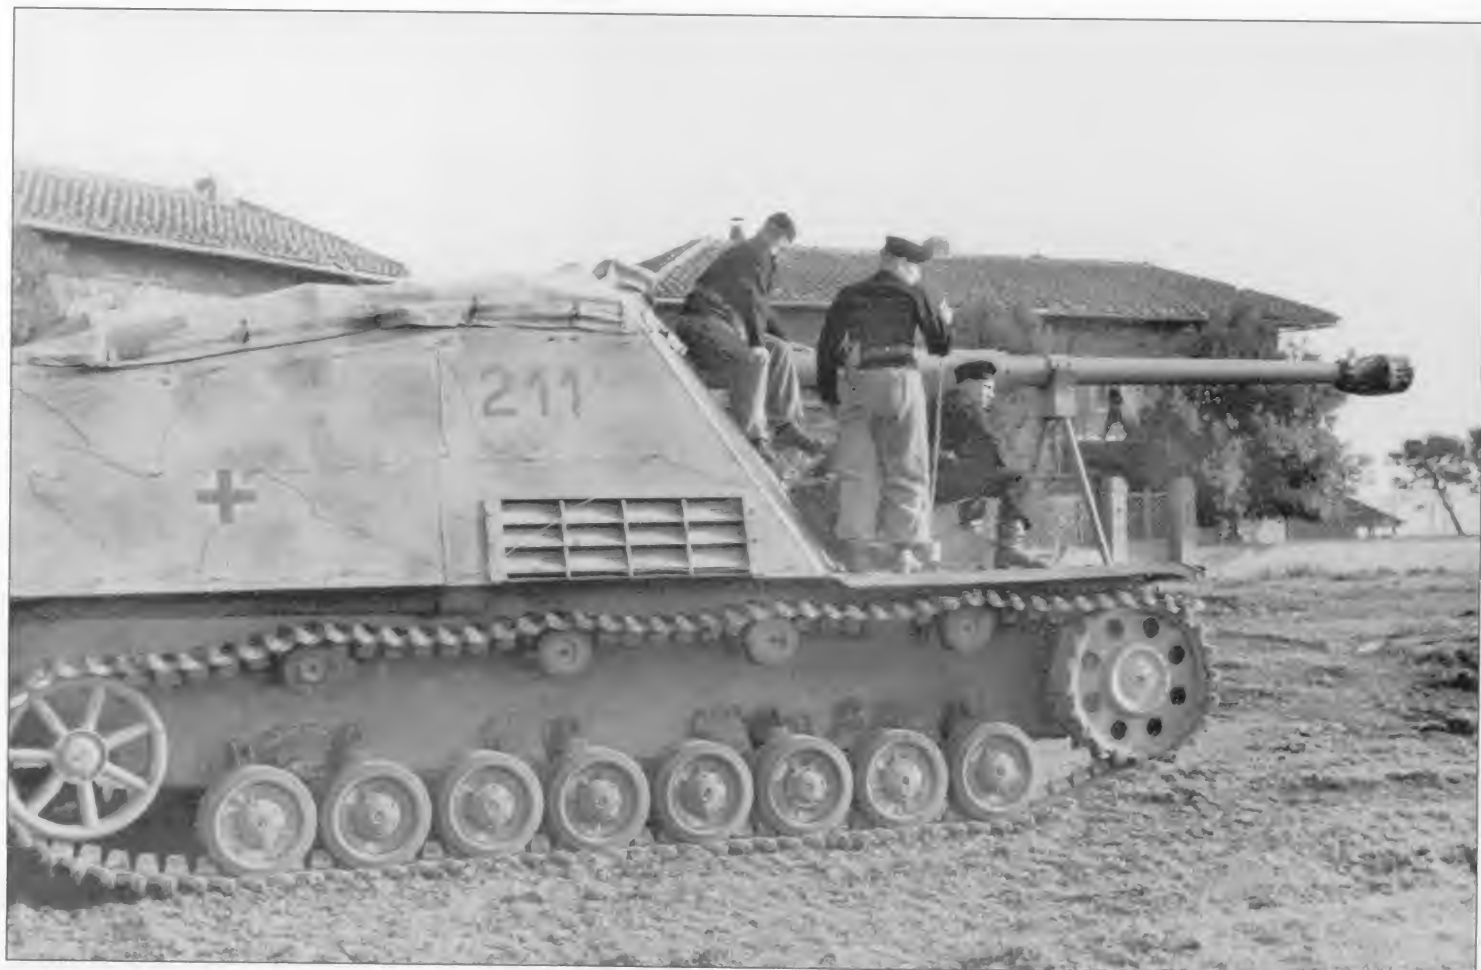
A 'Nashorn' halts in an Italian village awaiting orders to advance in support of its division. Note the heavy gauge wire spot-welded to the side of the superstructure in which to place camouflaging foliage and the canvas gun compartment cover, which appears to be dubbed with camouflage paint. The "211" is in black. Two of the crewmen wear field gray trousers with their black panzer tunics. This vehicle belongs to 2.Kompanie, schwere Heeres-Panzerjäger-Abteilung 525 near Anzio, March 1944.

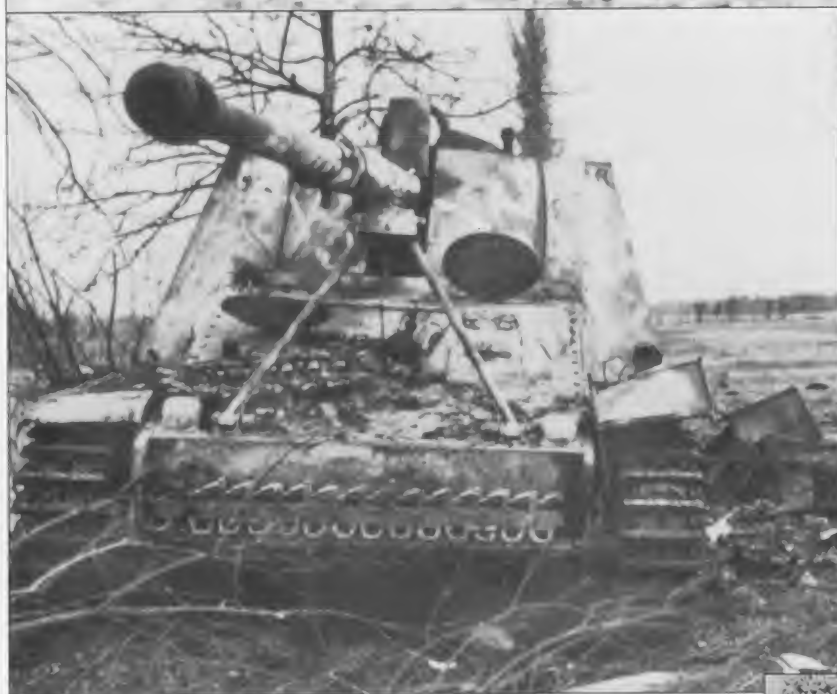
This 'Nashorn' took a direct hit to the right of the driver's compartment. Owing to the wreckage littered about it appears the ammunition exploded. The faded camouflage pattern, probably green and/or brown over dark yellow, has been partly over-painted by whitewash swaths as a hasty winter camouflage. It was knocked out by M10 tank destroyers of the French First Army in the Colmar area of France in early 1945.

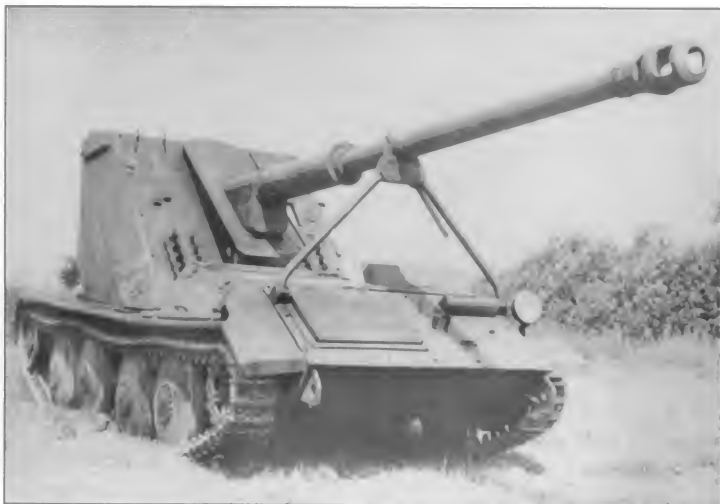
Looking almost too large for its carrier, this is an 8.8cm PaK 43/3 L/71 antitank gun mounted on a Pz.Kpfw.38(d) chassis. It was known as the 8.8cm PaK 43/3 Waffenträger. The gun entered service in late 1943 fitted on an anti-aircraft-type cruciform mounting. It was provided to counter the Soviet 122mm gun-armed IS-1 and IS-2 Stalin heavy tanks. For an antitank gun to be successful, as well as survive, it has to be capable of rapid emplacement and displacement. The bulky anti-aircraft-type mounting with outrigger arms was not conducive to this and the gun was mounted on several types of chassis, some more successful than others. The gun and its mount were far too heavy for Pz.Kpfw.38(t) and there was insufficient operating space for the crew. The number of 8.8cm rounds that could be stowed was insufficient as well. It was successfully tested in April 1945, too late to go into production.

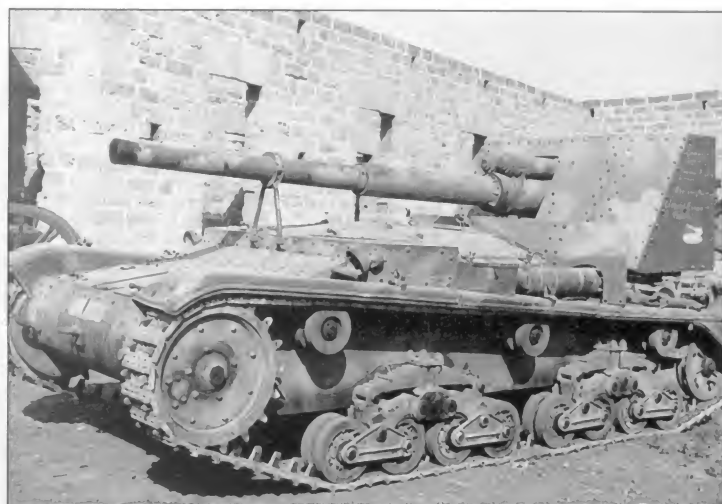
One of the more unusual self-propelled antitank pieces employed by the Germans was this Italian Semovente da 90/53 captured by American forces in Sicily in 1943. The 90mm gun was an anti-aircraft weapon, but in this configuration it served as a self-propelled antitank gun and was sometimes employed as an artillery piece. The gun, not the vehicle, was designated the 9cm FlaK 41 by the Germans. The crew stood on the ground to operate the weapon, a major shortcoming for a self-propelled antitank gun. It did have an 80-degree traverse, much wider than Marders. It was built on the M14/41 tank chassis in which the engine was relocated forward. Only eight rounds of ammunition were carried aboard the vehicle. An ammunition carrier modified from an L.6 light tank carrying 26 rounds and a trailer with another 40 rounds accompanied it. The Germans employed some in northern Italy as artillery after the Italian surrender, but found the long-barreled gun difficult to use in the mountains where howitzers could deliver more effective fire on reverse slopes. The white gun silhouette is an Italian unit symbol. The writing above the symbol: "Commanding General, Aberdeen Proving Ground, Aberdeen, Maryland, Captured Enemy Material."

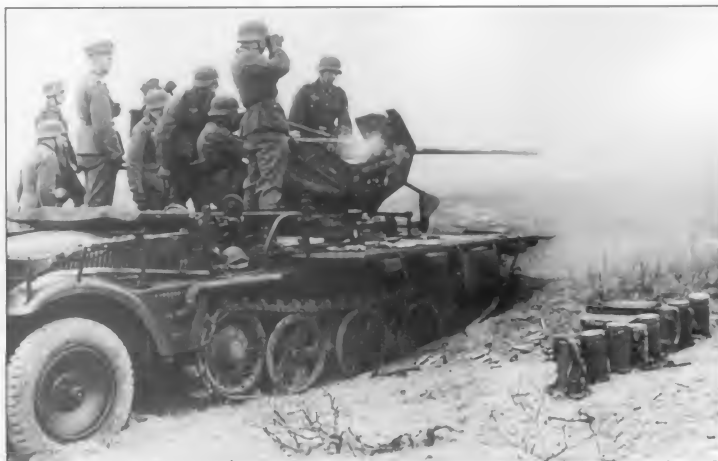
Photographed during a training exercise, this 2cm FlaK 30 mounted on a 1-ton Sd.Kfz.10/4 half-track pumps out rounds. The FlaK.30 had a practical rate of fire of 120 rounds per minute. The crew's gasmask canisters rest on the ground.

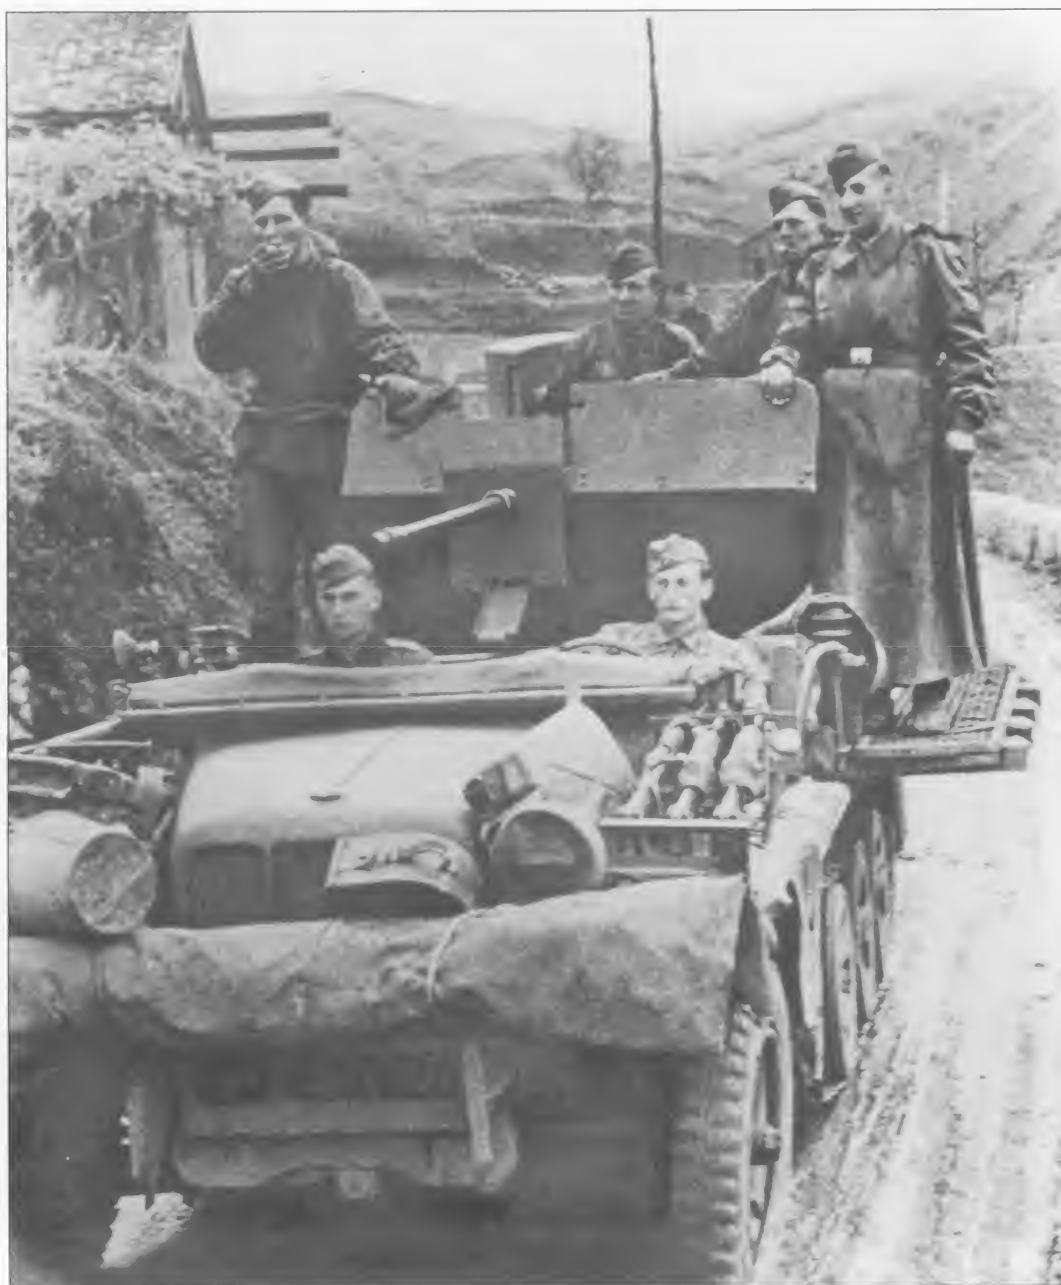
This 2cm FlaK 30 is seen on its more common self-propelled chassis, a 1-ton Sd.Kfz.10/4 half-track. The 2cm FlaK 38 was mounted on the same vehicle, in which case it was known as a Sd.Kfz.10/5. The sideboards had to be lowered in order to traverse either weapon and also provided the crew more workspace. The four projections beneath the sideboards are the tops of spare magazine containers. Note the rack on the vehicle's left fender for three carbines.

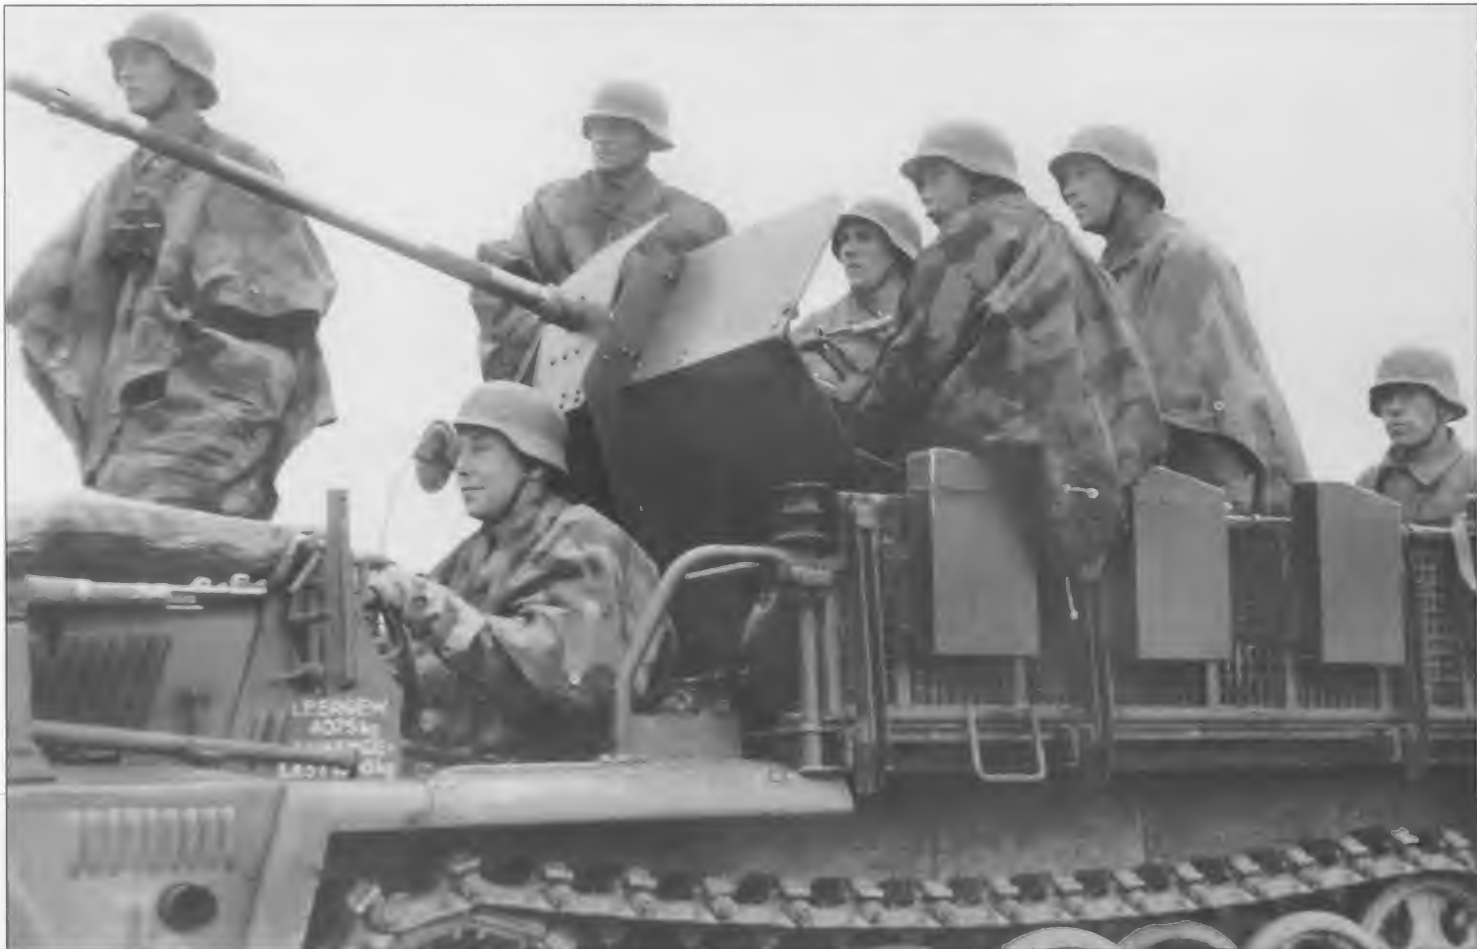
A half-track-mounted 2cm FlaK 30 crew wears shelter capes for rain protection. They could also be buttoned together to make a small tent. The capes' three-color (light and dark green, dark brown) splinter camouflage pattern is apparent. The FlaK 30 may be differentiated from the FlaK 38 by its straight flash suppressor; the FlaK 38's is cone-shaped. The Sd.Kfz.10/4 half-track's empty and loaded weight is painted in white letters beside the driver's compartment.

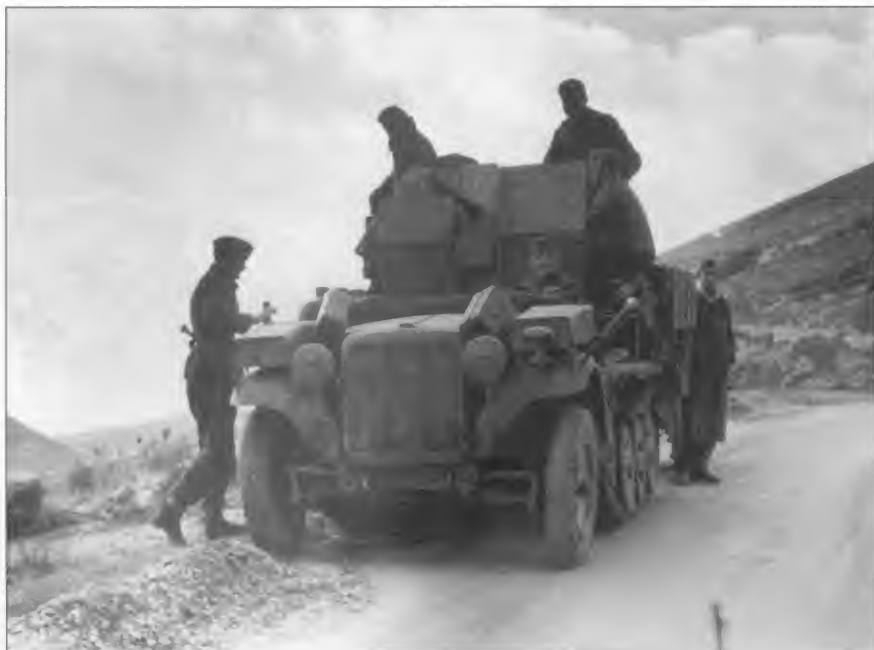
A half-track-mounted 2cm FlaK 38 crew awaits orders to move out. The two 20-liter fuel cans stowed between the carbine racks and the hood indicate this is a non-tactical road march. Note the blackout driving light covers on the headlights.

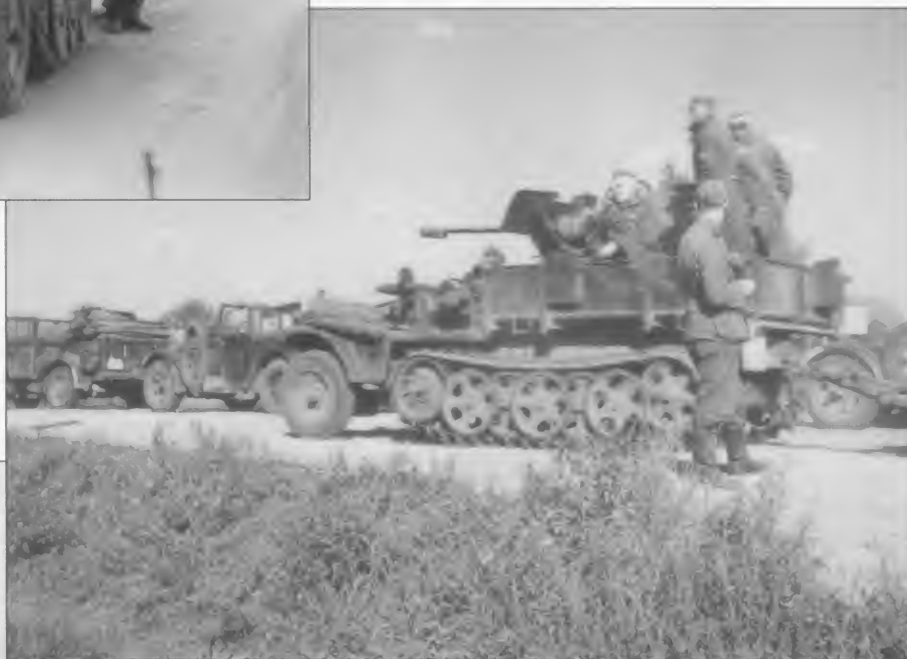
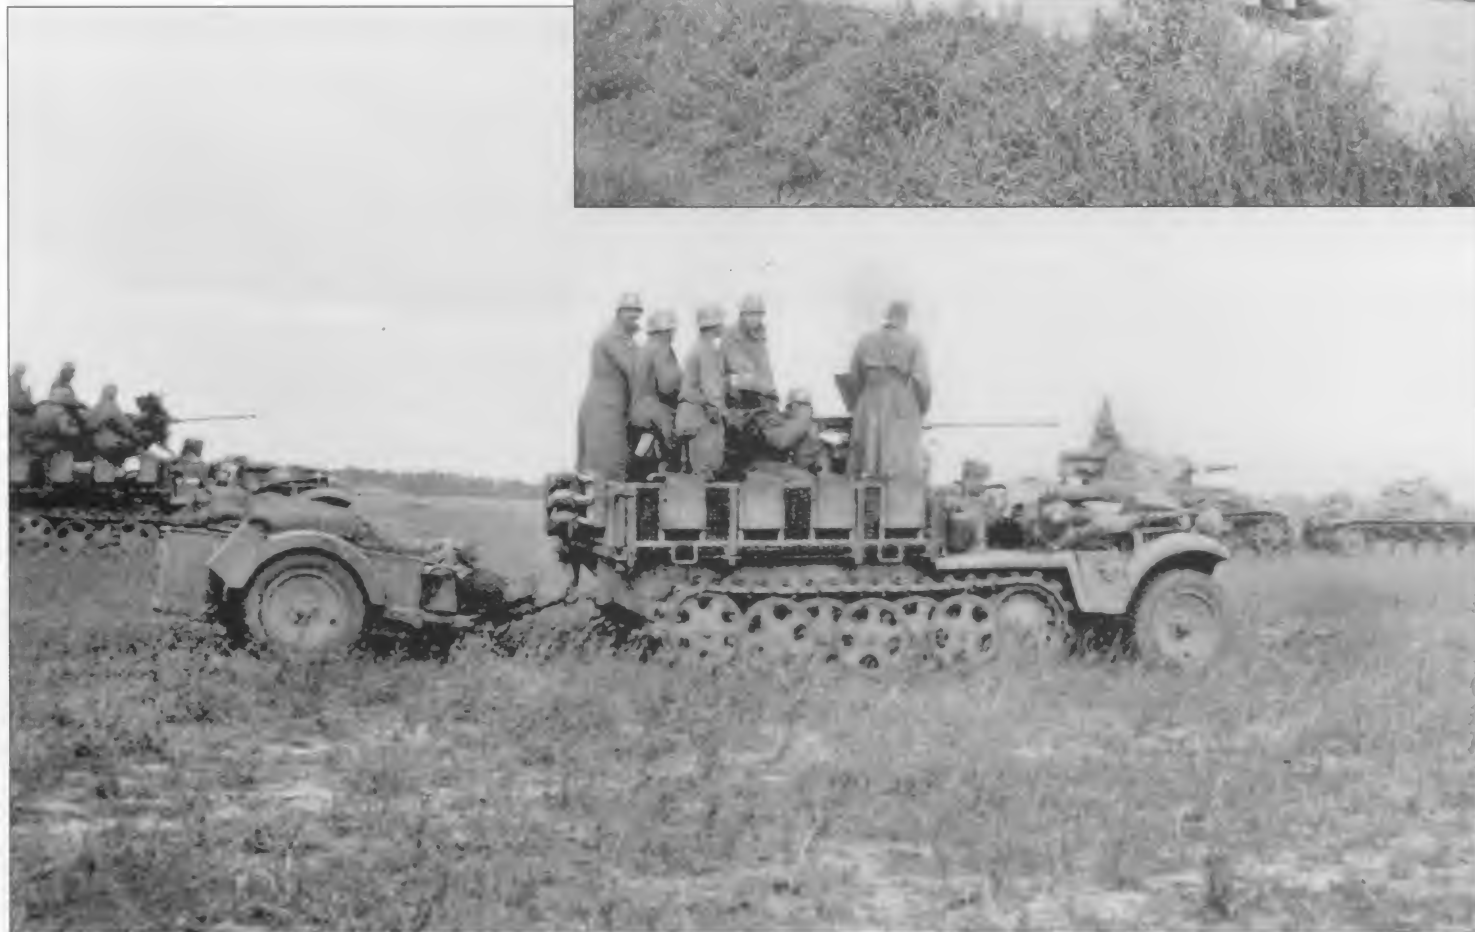
In milder weather, though still chilly as evidenced by the wear of greatcoats, a 2cm FlaK 38 on a Sd.Kfz.10/5 half-track waits beside a convoy it is escorting. Note the canvas muzzle cover. The towing bars of the gun's ammunition trailer can be seen.

The seven-man crew of this 2cm FlaK 38 on a Sd.Kfz.10/5 half-track demonstrates its cramped space, although the gun commander (Geschützführer) would normally ride in the front seat beside the driver. The trailer carried crew equipment and additional ammunition. A second Sd.Kfz.10/5 can be seen the left background while Pz.Kpfw.IV and II tanks are to the right background. Half-track-mounted 2cm guns frequently provided fire support to advancing tanks and were especially valuable for destroying machine gun and anti-tank gun positions. They would also place suppressive fire on wood lines and buildings suspected of sheltering the enemy.
